International Space Station Powered Bolt Nut Anomaly and Failure Analysis Summary

Daniel E. Sievers* and Harry K. Warden**

Abstract

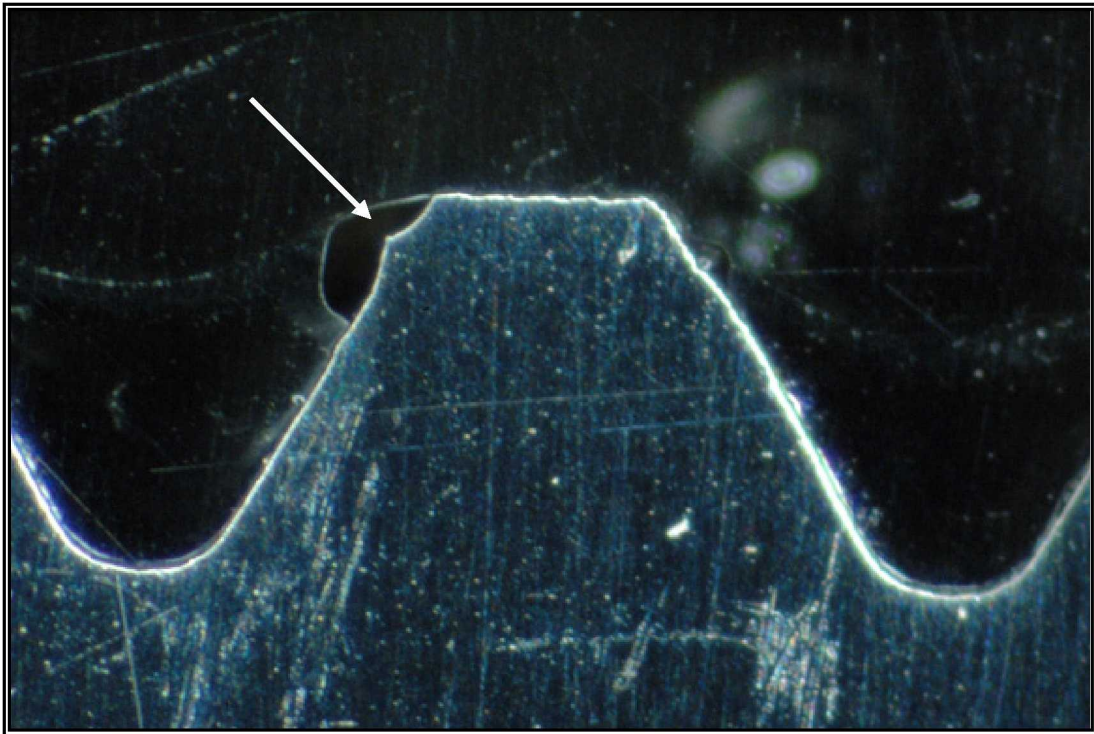
The machinist must ensure adequate and uniform lapping over all the internal threads with a hand tool specially made for the PBN thread dimensions to ensure burrs are removed and the required 16 micro-inch finish is obtained. The lapping process for the 2009 PBNs consists of machining a bolt to proper dimensions and covering it with lapping compound. When choosing a hand tool to lap the nuts and remove burrs left from machining, the hand tool material must be softer than the nut base material. This is to ensure the burrs will be removed and the base metal will not be damaged by galling with the hand tool. The best way to ensure an adequate finish is to fully engage the softer material tool with lapping compound multiple times to wear down any burrs left from machining. This process was implemented for the 2009 PBNs to smooth out burrs and meet required finishing while opening the nut pitch diameter before the application of lubricant. Figure 2, shown in the Appendix, is a surface finish error (burr) that occurred due to inadequate machining and lapping of the 2007 PBNs. This error may seem minuscule, but when requiring the Powered Bolt to autonomously attach two pressurized elements of the ISS together, a small burr will quickly break through the thin dry film lubricant and cause galling of the Powered Bolt Assembly.

The PBNs fabricated in 2007 were polished with a lathe and polishing sponge. The lathe and sponge method is unable to polish in the grooves of the PBN threads; therefore this method will not meet the thread call out and finish of the specified PBN drawing. This process not only leaves room for potential burrs but also does not evenly open the thread pitch. Using a lathe and sponge technique could also damage the threads of the nut if the machinist calculates dimensions wrong or a sizable previously made burr gets caught on the lathe. The PBNs fabricated in 2009 were correctly dimensioned and lapped to open the pitch diameter in order to meet the PBN drawing specifications.

Figure 2: Surface Finish error, burr; 500x magnification

- When lapping a surface, a method which is capable of obtaining the desired surface finish in every thread, groove, etc... must be determined and controlled. In this case, manual thread lapping with a "softer" tool and lapping compound, lapped multiple times worked well to wear down any burrs left from machining.
- Polishing with a lathe and sponge method was eliminated.
- Use of a go/no-go gauge before lubrication to check for correct thread dimensions was implemented.

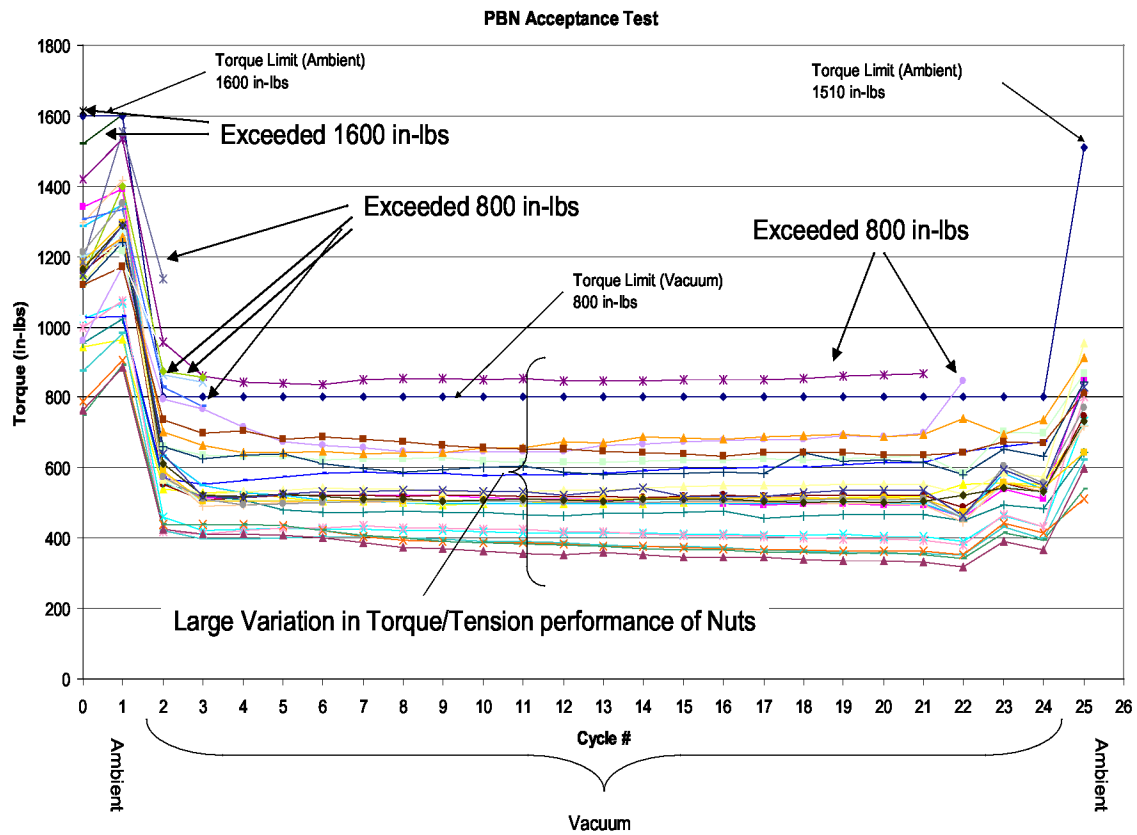
Figure 3: Acceptance test data from failed PBN lot of 2007

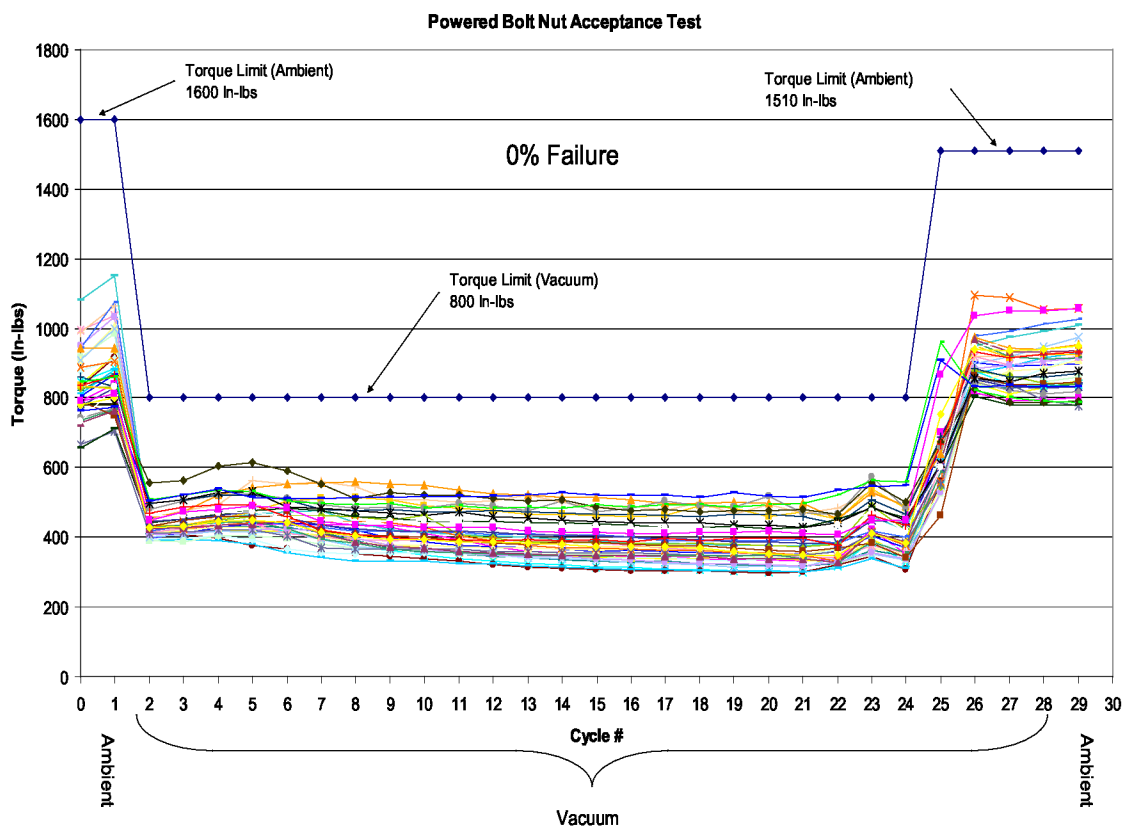
Figure 4: Acceptance test data from passed PBN lot of 2009

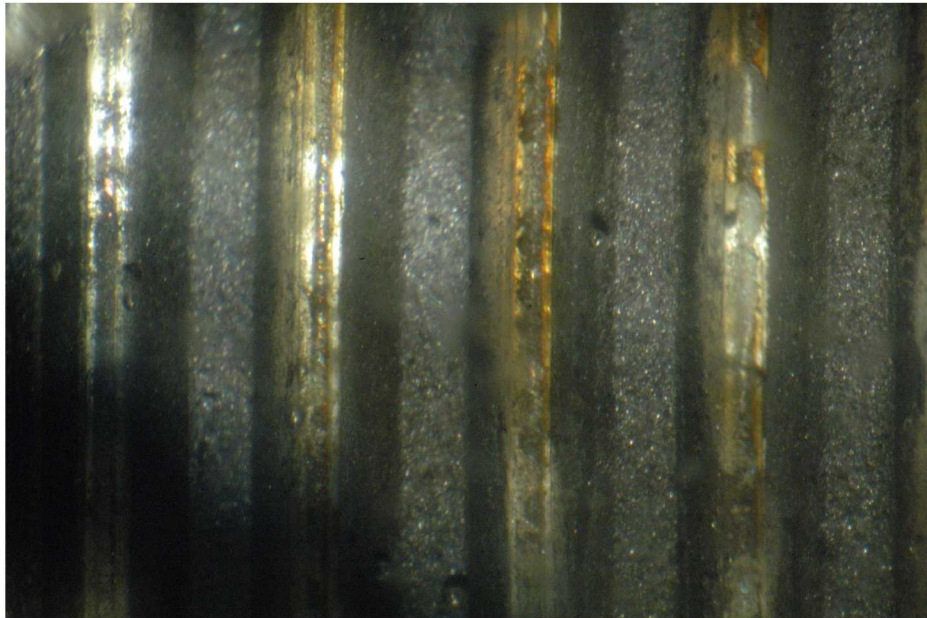
Figure 6: Amber coloration of resin binder; 50x magnification

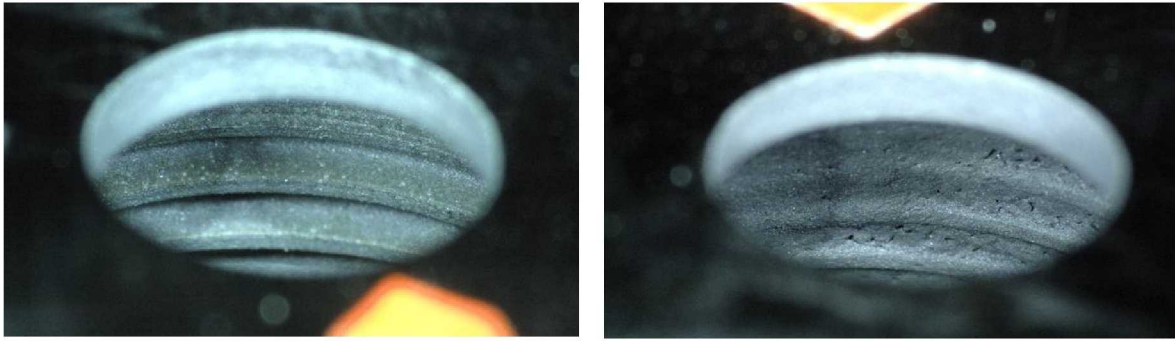
Figure 7: 2 180° views of a failed PBN; 50x magnification

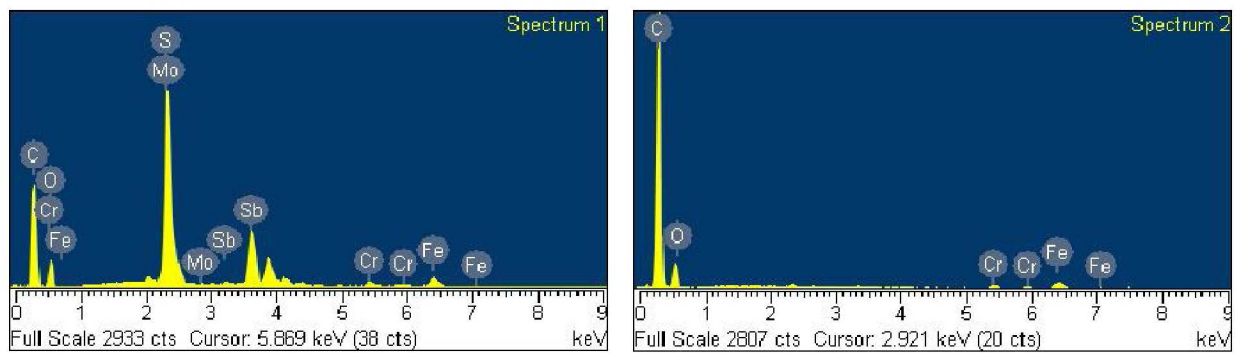
A way of analyzing lubricant for composition is using an Energy Dispersive Spectrometer (EDS). This equipment will show if lubricant is missing from the threads. The EDS indicated that the ceramic base coat was applied to the threads before the resin top coat. Figure 8, located in the Appendix, shows EDS images of a PBN which failed acceptance testing. Spectrum 1 is of a non-amber colored area and Spectrum 2 is of an amber colored area. The chemistry shows the absence of the Molybdenum disulfide (MoS_2) and Antimony (Sb) which make up the ceramic base coat of Vitro-lube NPI-1220C. This absence of ceramic base coat is a direct cause of not preheating the PBNs before lubrication.

Figure 8: Differences in coating chemistry of PBN

- To maintain consistent lubrication thickness a thread cutting technique was implemented over a thread rolling tap. Consideration of final lubricant dimensions is a key aspect of choosing a cutting tap.
- A preheating process was implemented to obtain proper flash temperature. Due to the migrating capabilities of dry film lubricants that are applied on to substrates as liquids, it is beneficial to preheat all mechanisms to defer and risk of lubricant pooling or lack of lubricant in less energy potential areas.
- Imposing an out of oven time limit during the lubrication process to keep the mechanisms at flash temperature.
